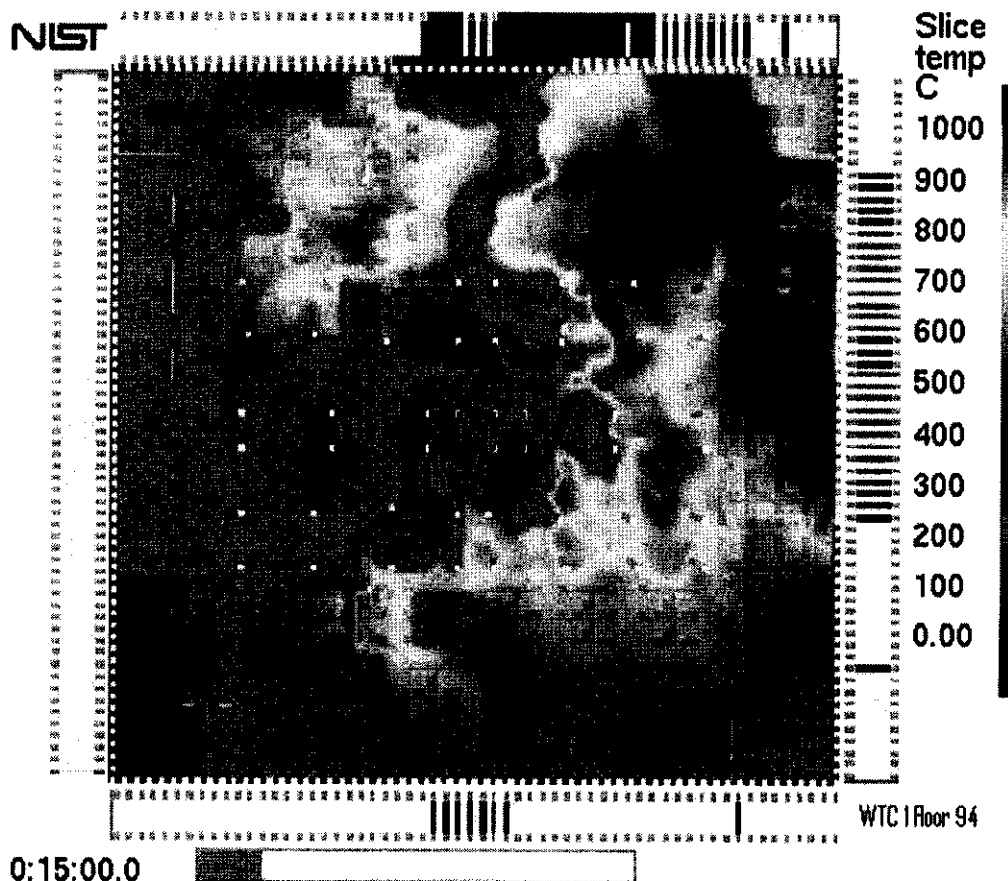
Figure 6–36. Upper layer temperatures on the 94th floor of WTC 1, 15 min after impact.

Given the uncertainties in some of the floor plans, the damage to the internal walls, and movement of the office furnishings, the intent of the simulations was to capture the magnitudes of the fires and the broad features of their locations and movement; and they did so.

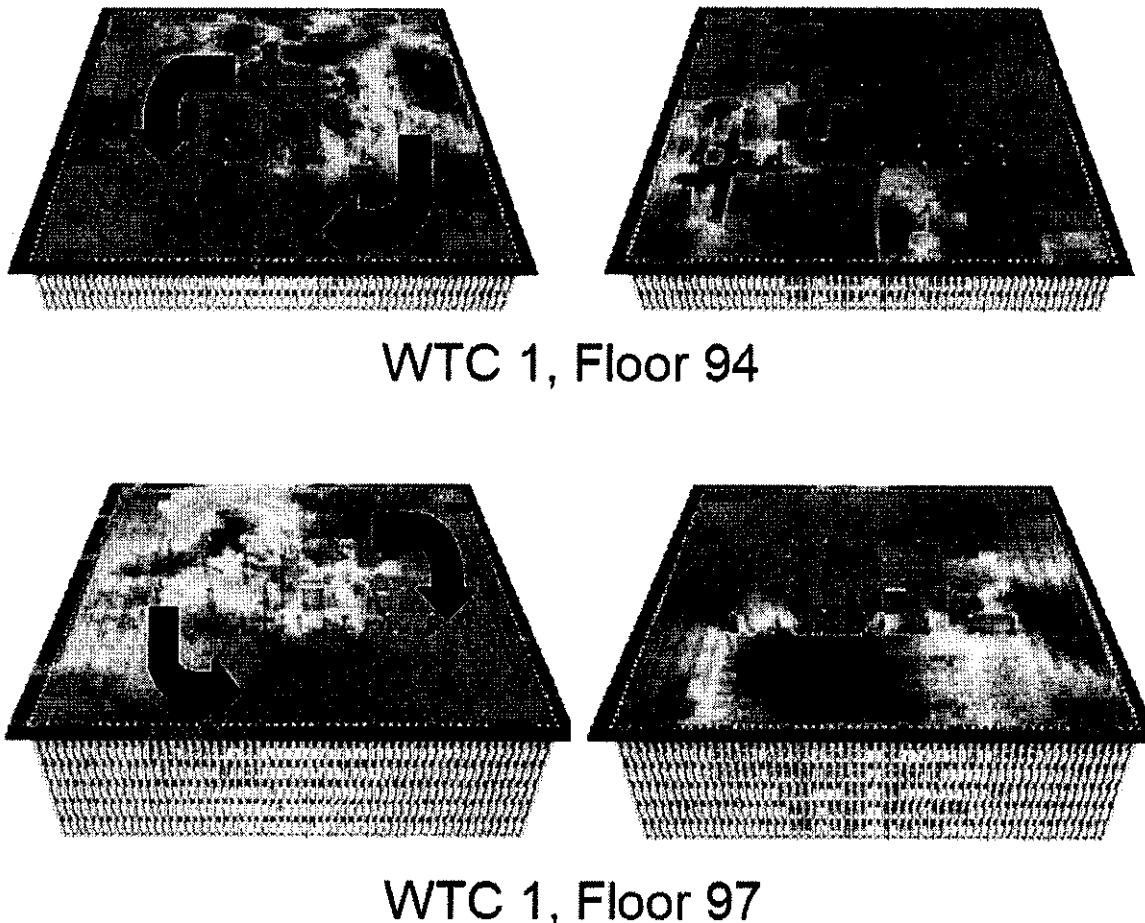
Much of the fire activity was initially in the vicinity of the impact area in the north part of the building. As a result of the orientation of the impacting aircraft and its fuel tanks, the early fires on the 92nd through 94th floors tended toward the east side of the north face, while the early fires on the 97th through 99th floors tended toward the west side of the north face. The fires on all the floors spread along the east and west sides and were concentrated in the south part of the building at the time of collapse, as depicted in Figure 6–37.

Figure 6–37. Direction of simulated fire movement on floors 94 and 97 of WTC 1.

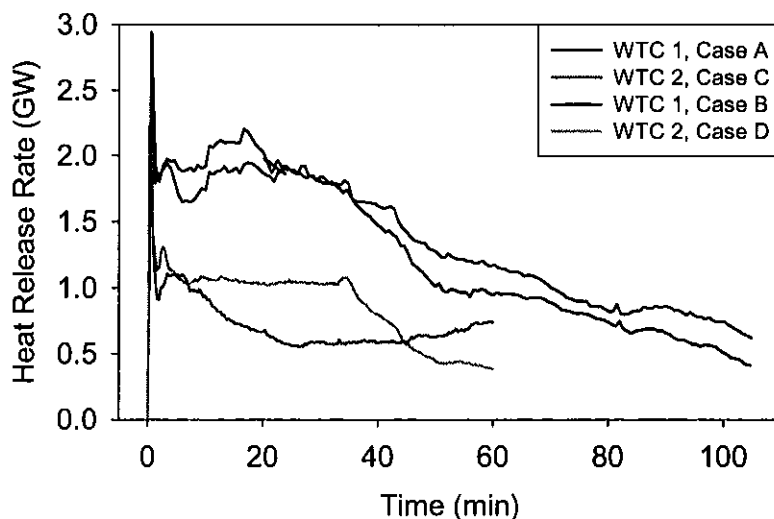
Much of the information needed to simulate the fires came from laboratory-scale tests. While some of these involved enclosures several meters in dimension and fires that reached heat release rates of 10 MW and 12 GJ in total heat output, they were still far smaller than the fires that burned in the WTC towers. Figure 6–38 shows the heat release rates from the FDS simulations of the WTC fires. The peak plateau heat release rates were about 2 GW for WTC 1 and 1 GW for WTC 2. Integrating the areas under these curves produced total heat outputs from the simulated fires of about 8,000 GJ from WTC 1 and 3,000 GJ from WTC 2.

Figure 6–38. Predicted heat release rates for fires in WTC 1 and WTC 2.

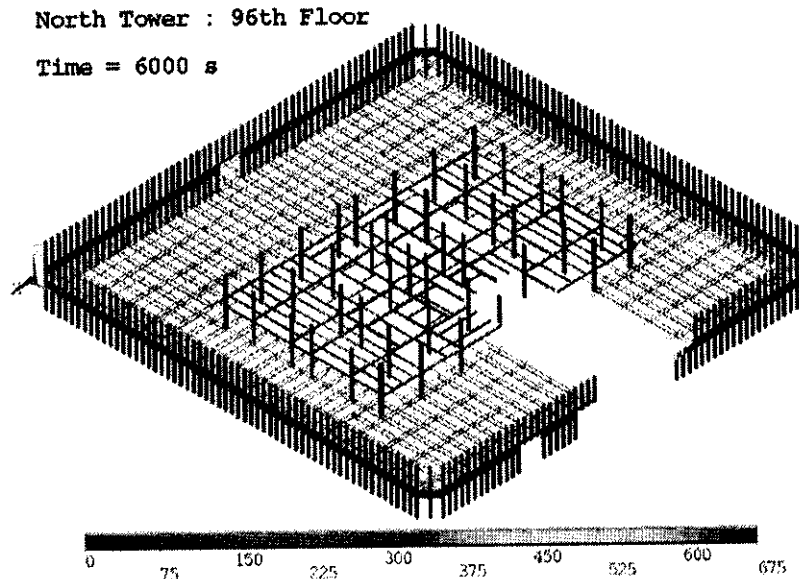
For ease of visualization, two graphic representations were developed. Figure 6-46 shows an example of the temperature map for the 96th floor of WTC 1. Severed columns and broken floor segments are not shown. Figure 6-47 shows a similar map for the 81st floor of WTC 2.

Figure 6-46. Temperatures (°C) on the columns and trusses of the 96th floor of WTC 1 at 6,000 s after aircraft impact, Case B.

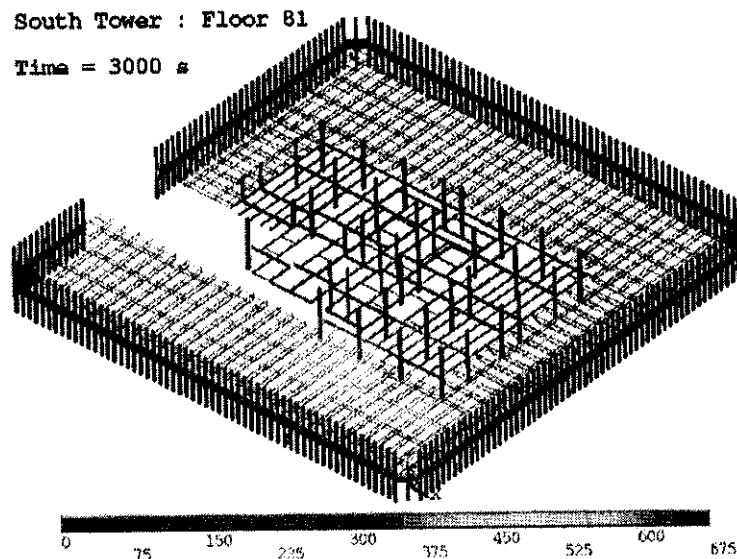
Figure 6-47. Temperatures (°C) on the columns and trusses of the 81st floor of WTC 2 at 3,000 s after aircraft impact, Case D.

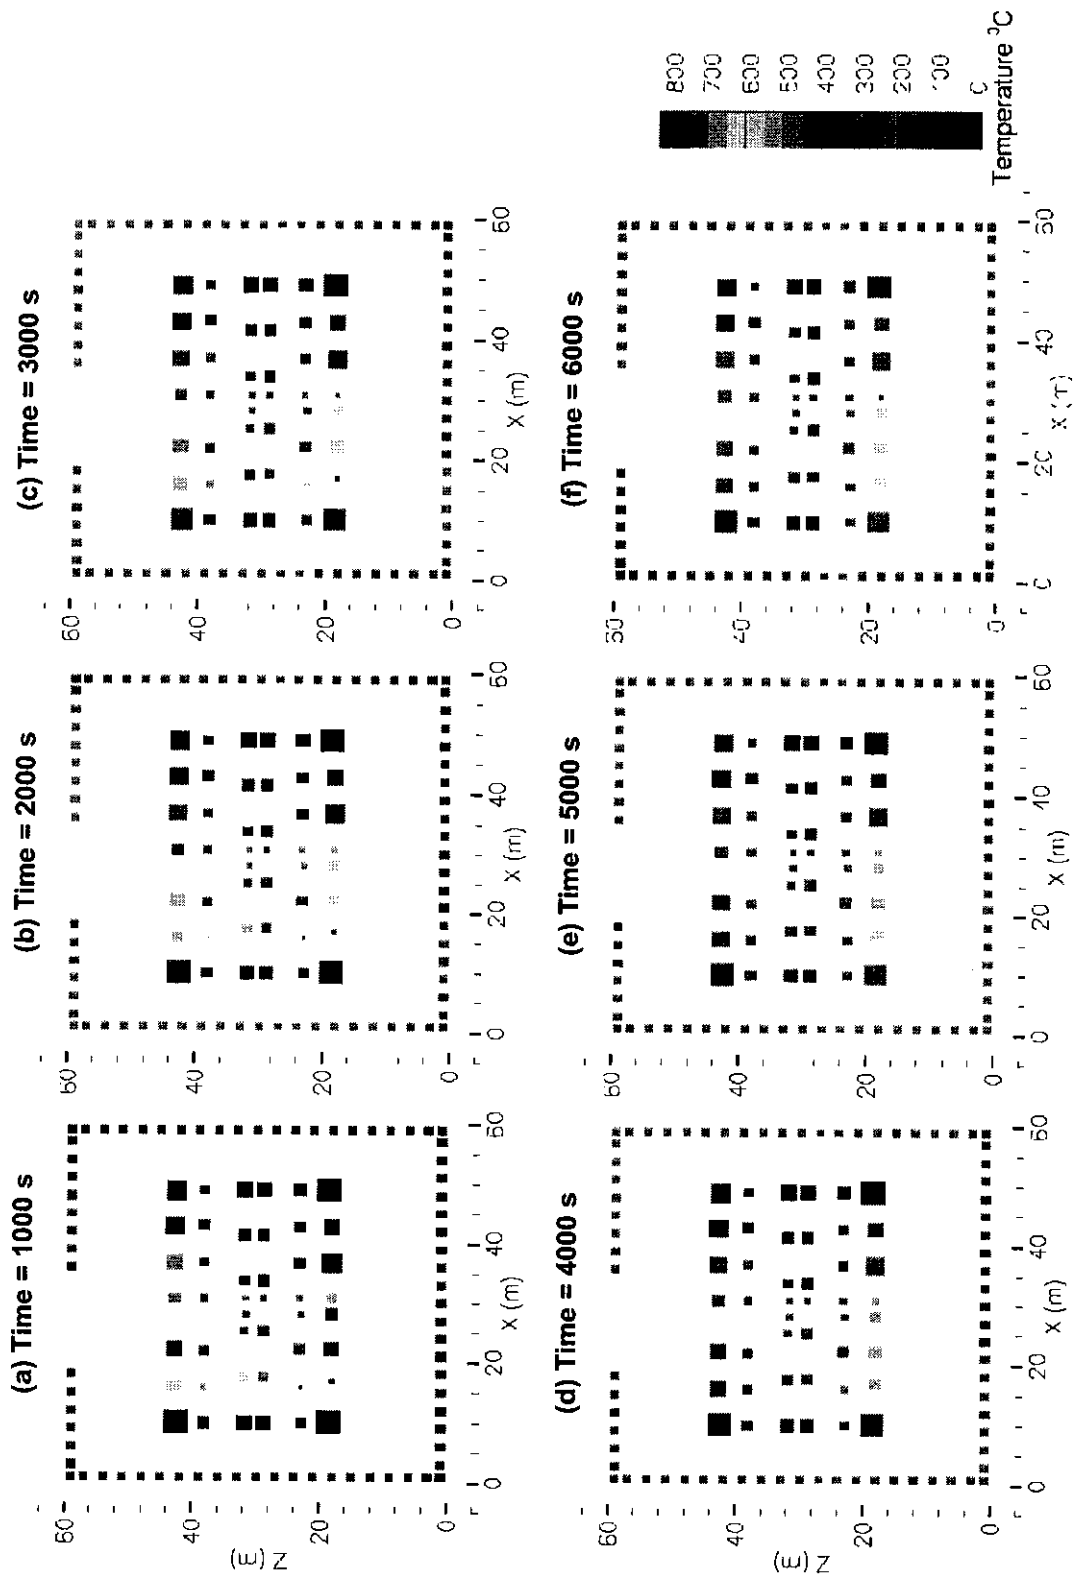
A third visualization tool was animation of the evolving temperatures of the columns. Frames from an example, again of the 96th floor of WTC 1, Case A, are shown in Figure 6-48. The size of the square representing a column represents its yield strength. Columns may have been heated when the fire was nearby and then cooled after the local combustibles were consumed.

Figure 6-48. Frames from animation of the thermal response of columns on the 96th floor of WTC 1, Case A.

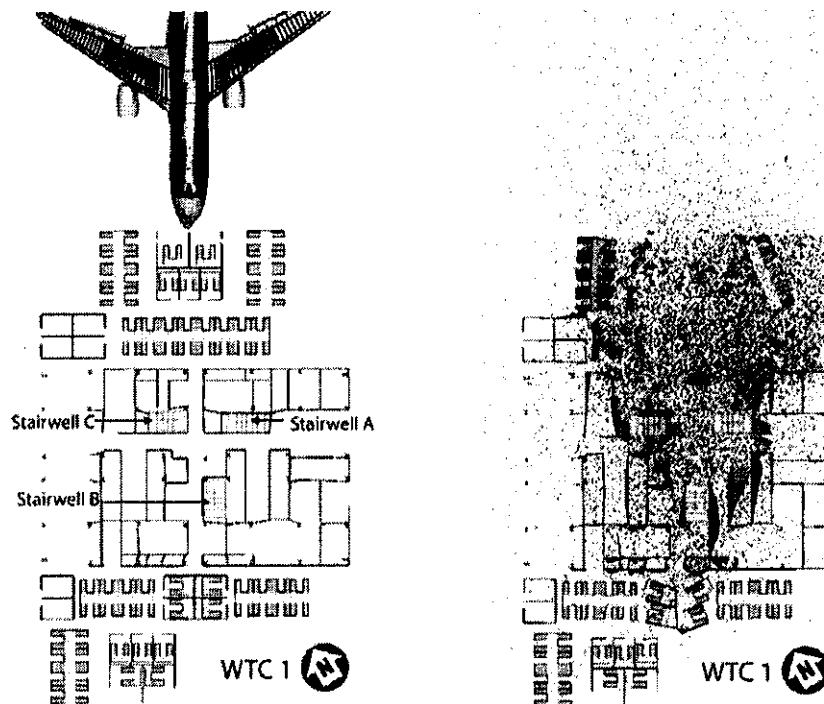
Figure 7-1. Simulated impact damage to 95th floor of WTC 1, including stairwells, 0.7 s after impact.

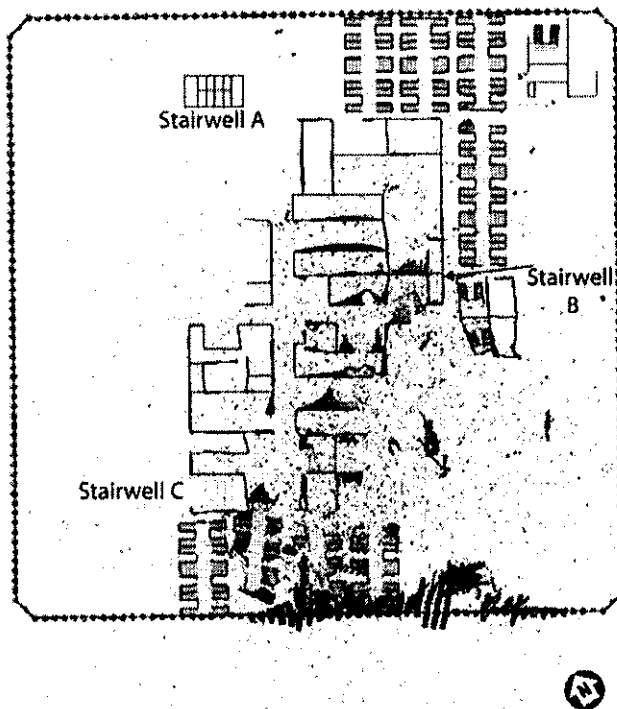
along different boundaries of the building core. United Airlines Flight 175 destroyed Stairwells B and C, but not Stairwell A (Figure 7-2).

Figure 7-2. Simulated impact damage to WTC 2 on floor 78, 0.62 s after impact.

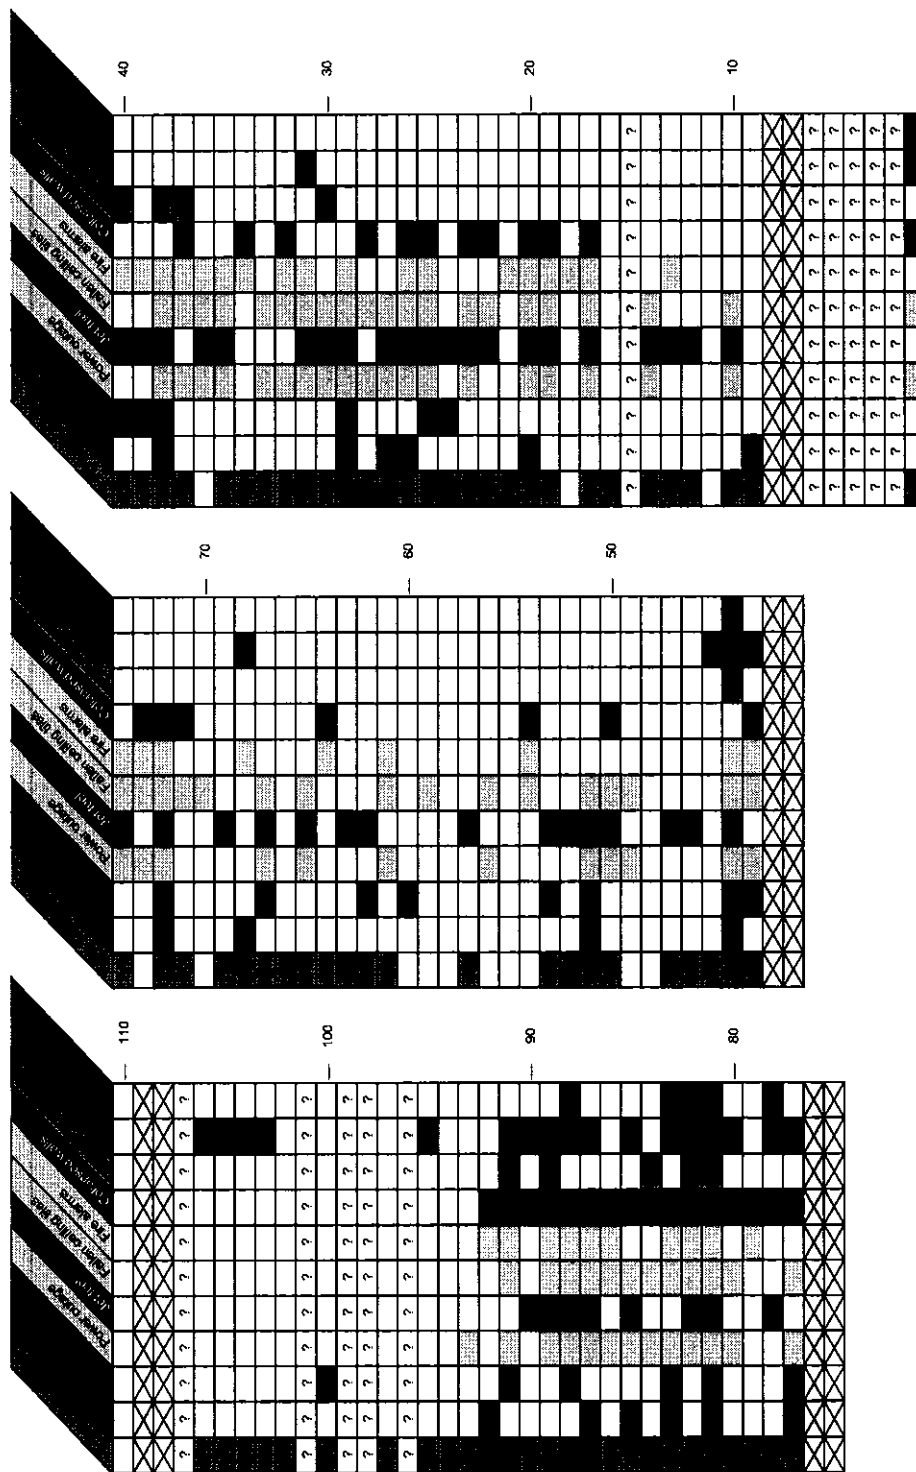
Figure 7-3. Observations of building damage after initial awareness but before beginning evacuation in WTC 1.

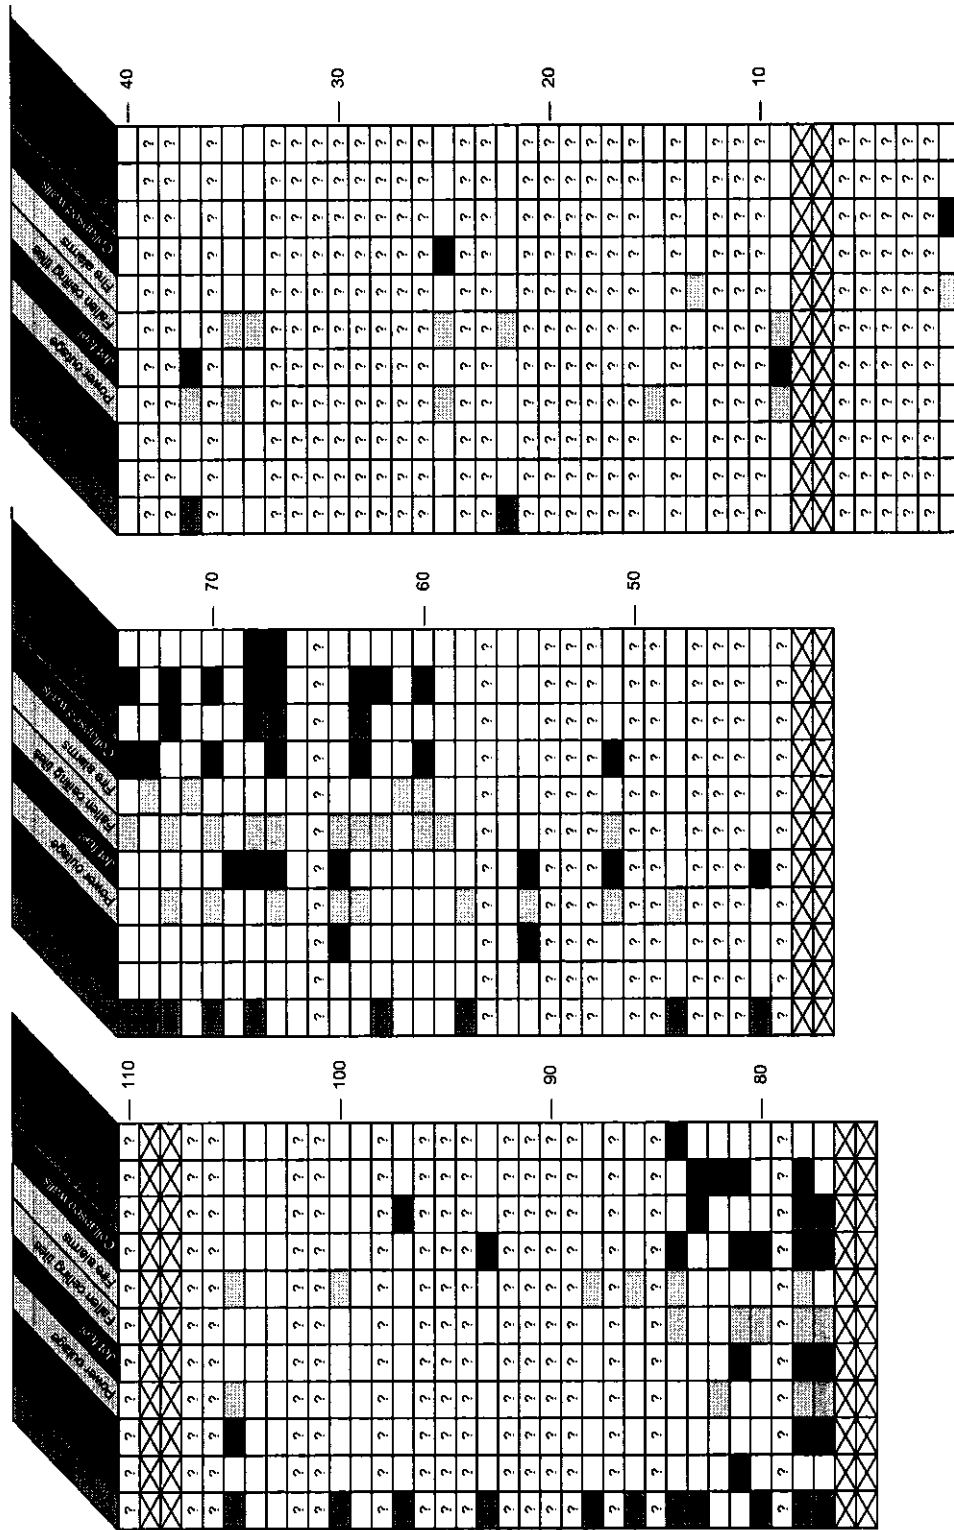
Figure 7-4. Observations of building damage from tenant spaces in WTC 2.
